Advanced Technology Composite Fuselage—Materials and Processes

The Boeing Company • Seattle, Washington

This document is one of nine complementary final technical reports on the development of advanced composite transport fuselage concepts. The work described was performed by the Boeing Commercial Airplane Group, Seattle, Washington, from May 1989 through December 1995 under contracts NAS1-18889 and NAS1-20013, Task 2. The contracts were sponsored by the National Aeronautics and Space Administration, Langley Research Center (NASA-LaRC) as part of the Advanced Composite Technology (ACT) program. Direction from NASA-LaRC was provided by M.J. Shuart, J.G. Davis, W.T. Freeman, and J.B. Nelson.

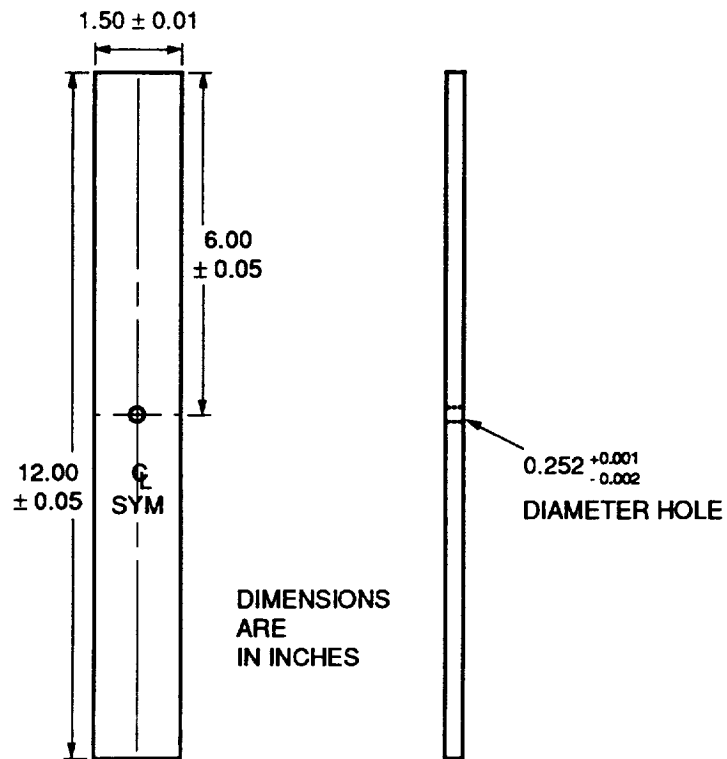
Figure D-1: Open hole tension and compression specimen configuration.

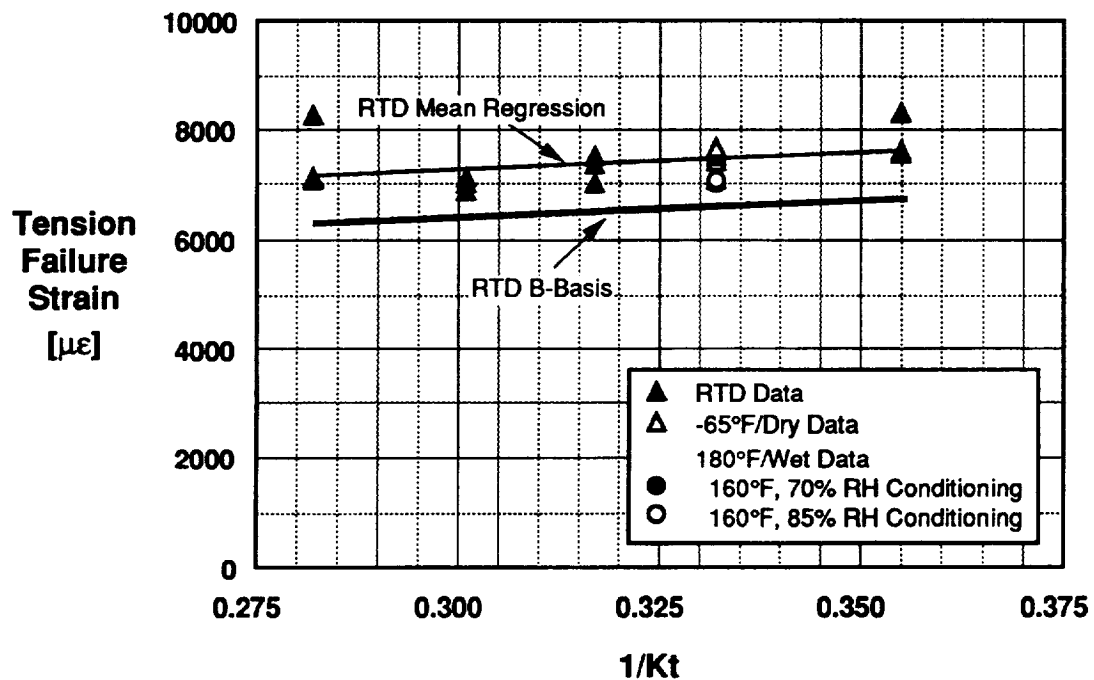
Figure D-9: Open hole tension failure strains vs. inverse of stress concentration factor.

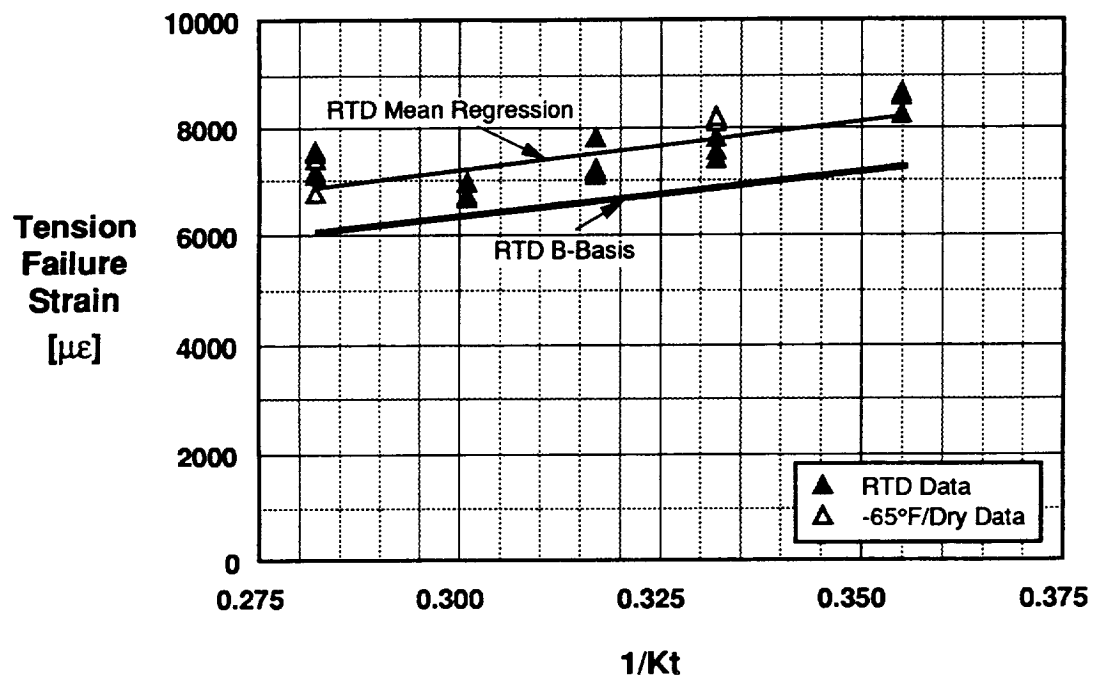
Figure D-10: Filled hole tension failure strains vs. inverse of stress concentration factor.

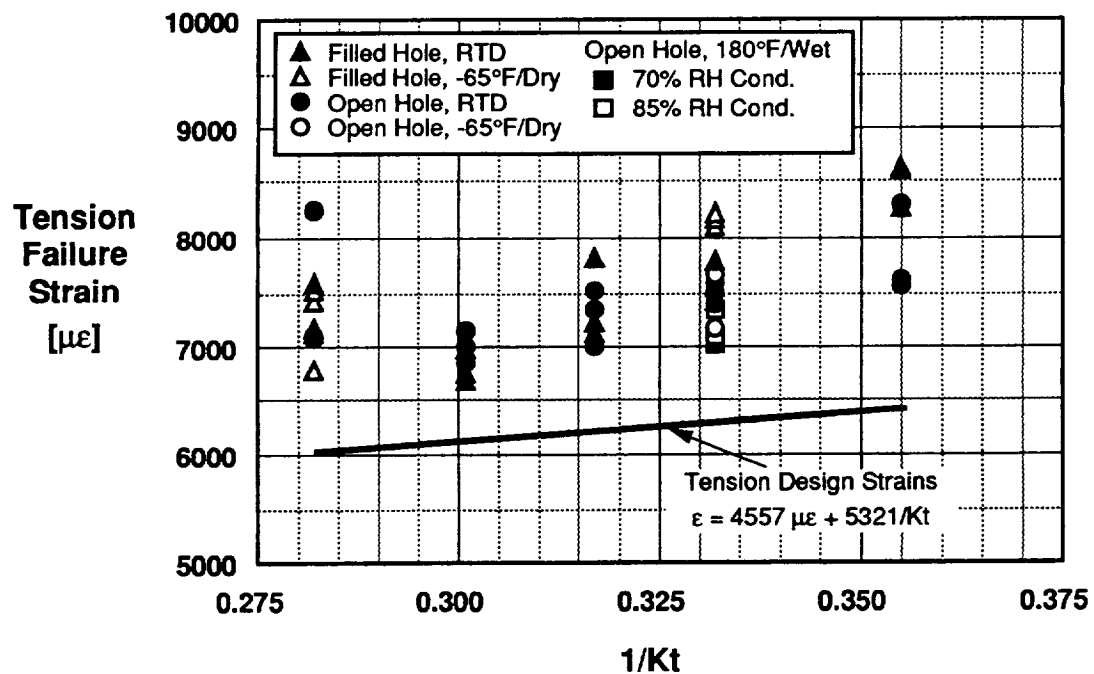
Figure D-11: Filled and open hole tension data versus tension allowable strain.

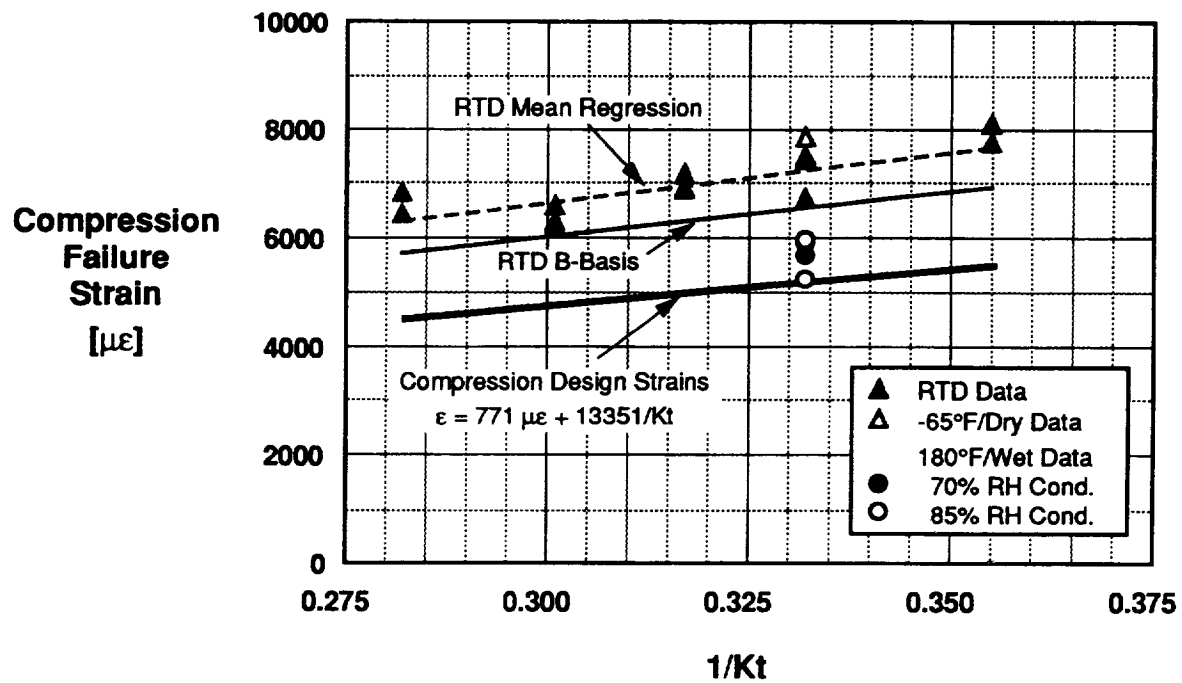
Figure D-12: Open hole failure strains vs. inverse of stress concentration factor and compression allowable strain.

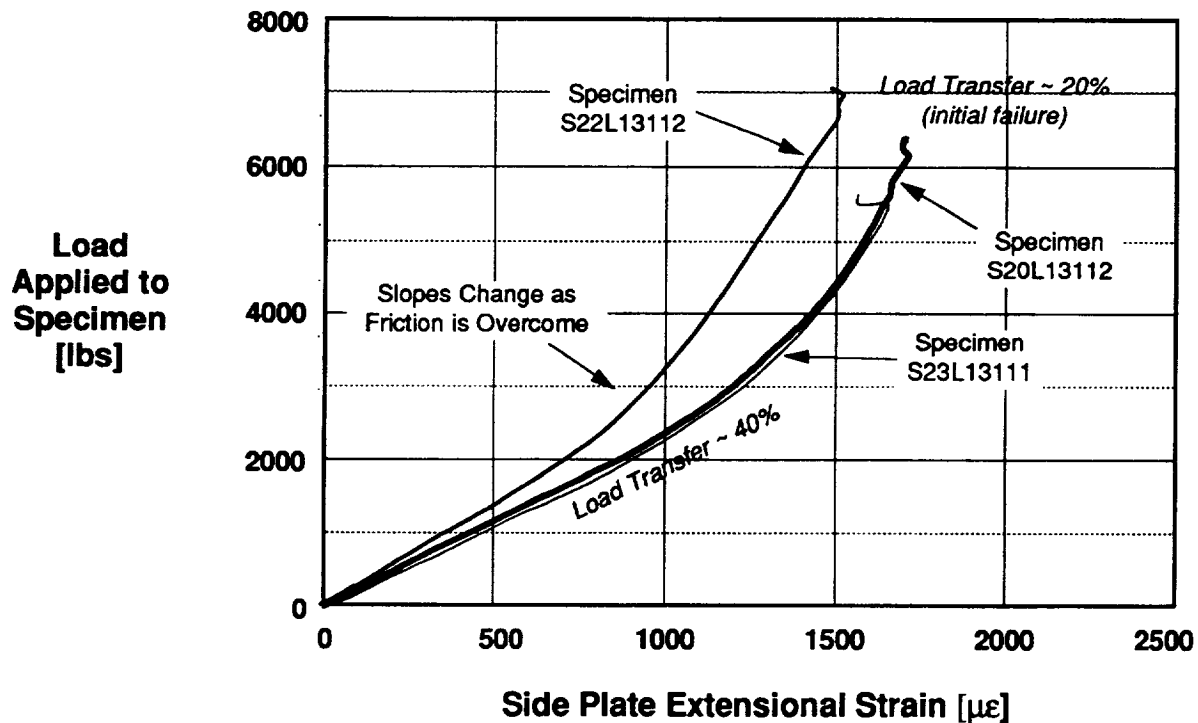
Figure D-13: Comparison of typical load plate strains vs. load applied for low load transfer specimens.

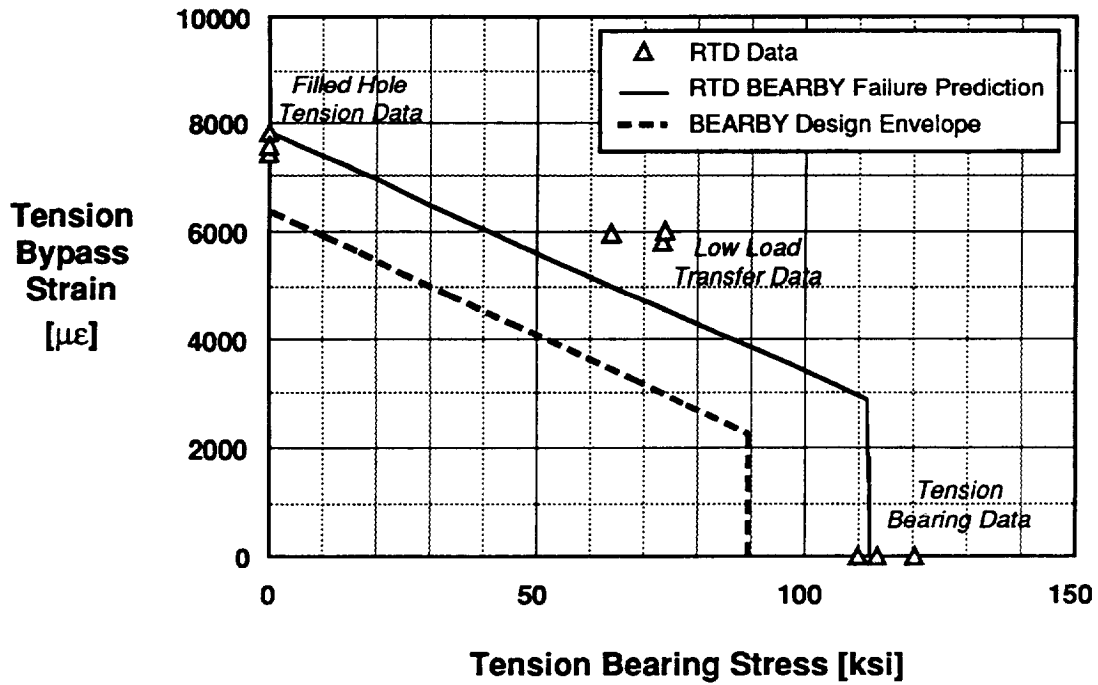
Figure D-14: Bearing-bypass test data, failure predictions and design envelope for laminate S20.

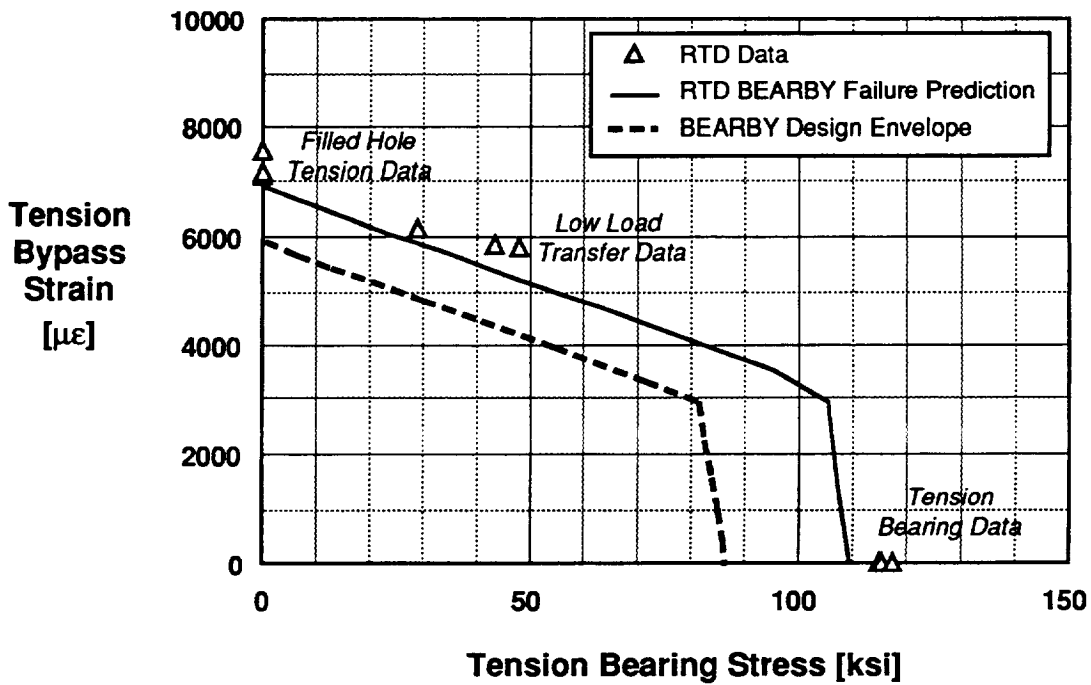
Figure D-15: Bearing-tension bypass test data, failure predictions and design envelope for laminate S22.

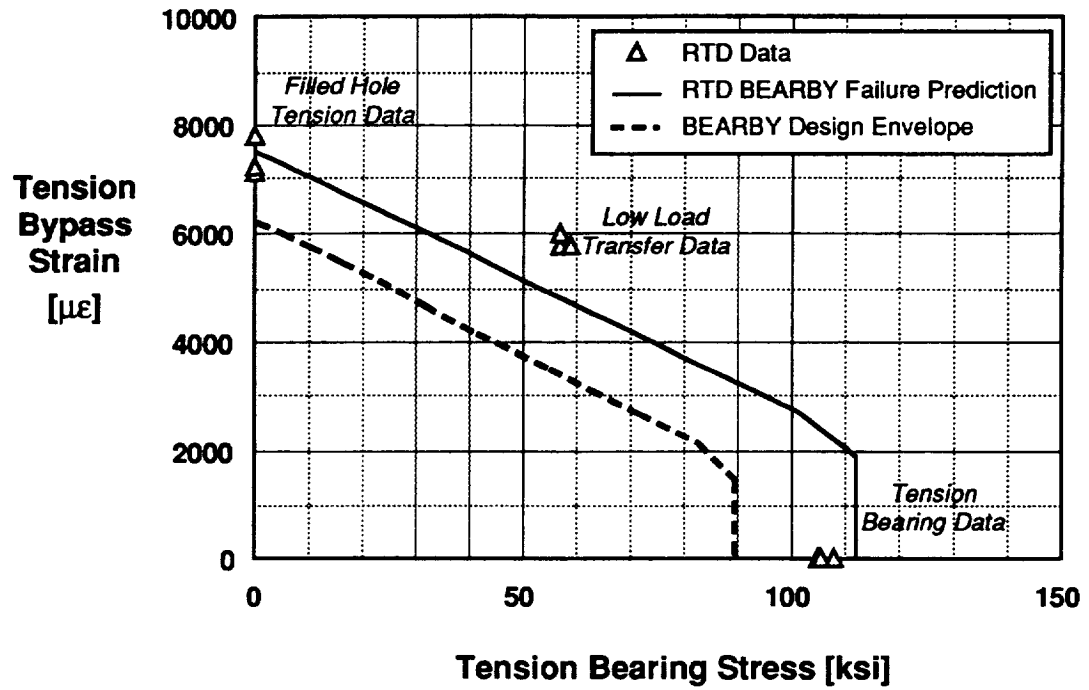
Figure D-16: Bearing-bypass test data, failure predictions and design envelope for laminate S23.

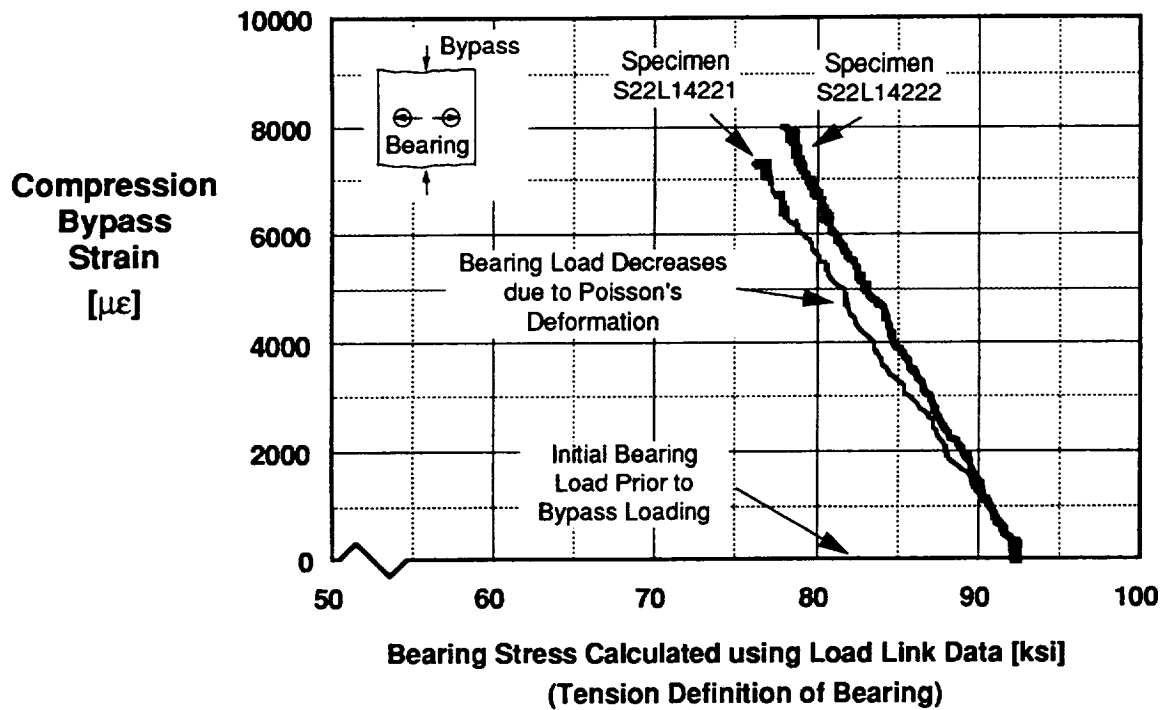
Figure D-17: Typical transverse bearing stress vs. applied bypass strain data obtained using instrumented load links.

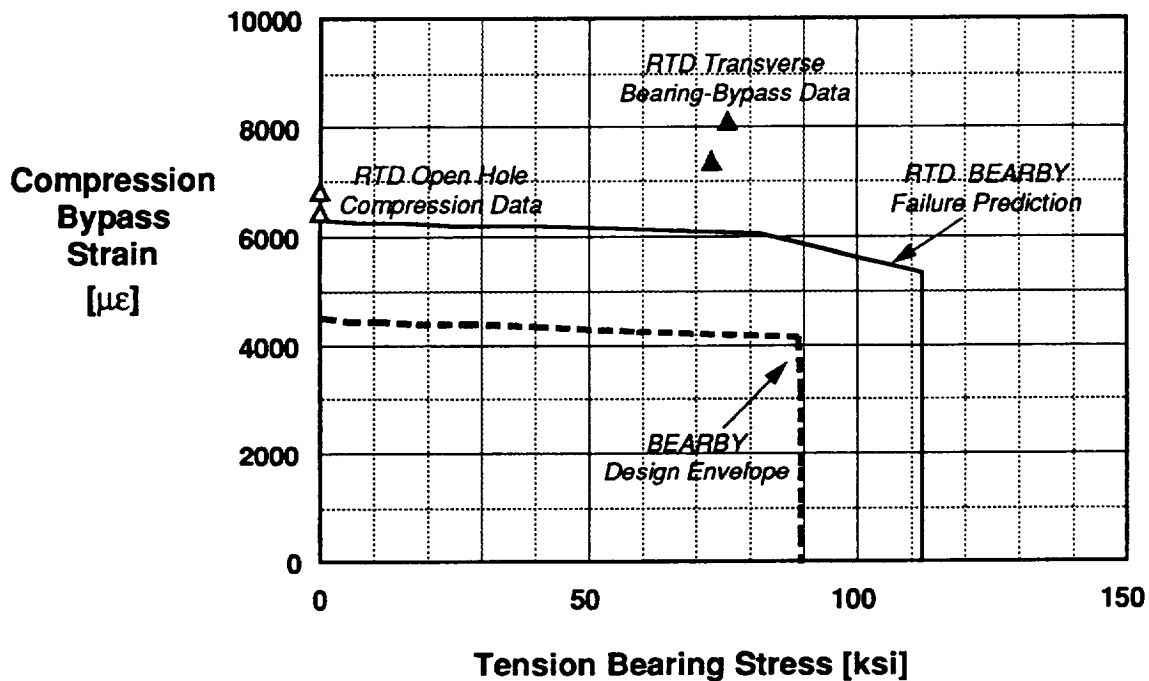
Figure D-18: Comparison of transverse bearing-compression bypass test data with open hole compression data, failure predictions and design envelope for laminate S22. Analysis predictions are based upon open hole compression bypass data.

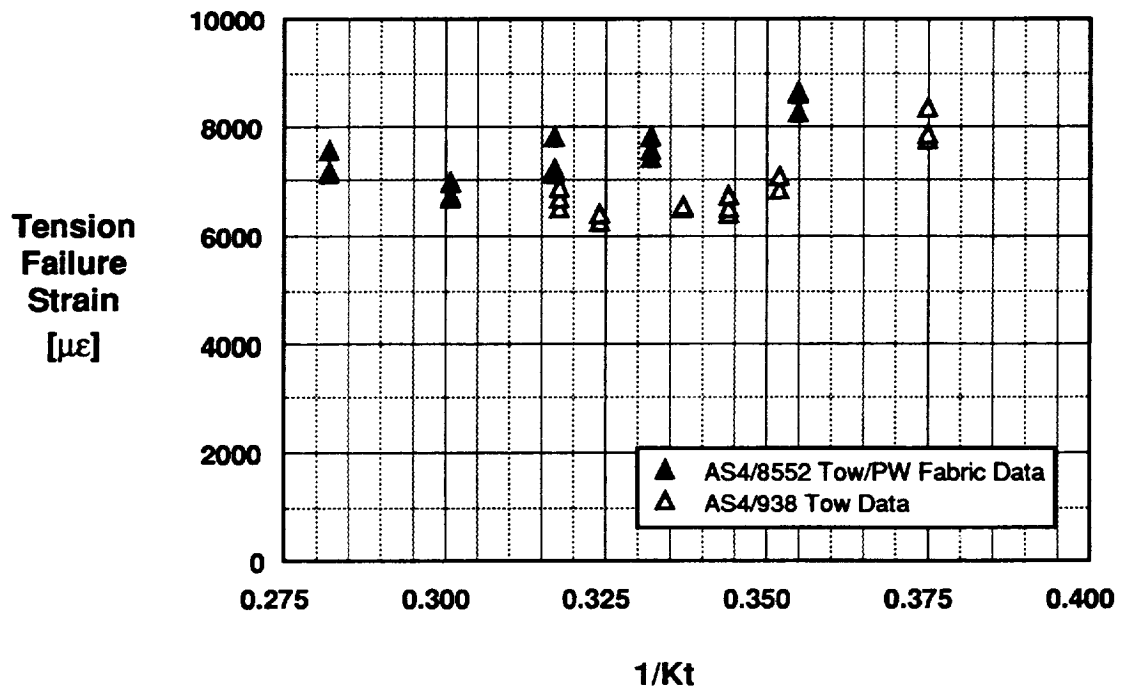
Figure D-19: Comparison of filled hole tension RTD failure strains for AS4/8552 tow/PW fabric hybrid laminates (MDOC keel & side panels) and AS4/938 tow laminates (ATCAS crown panel).

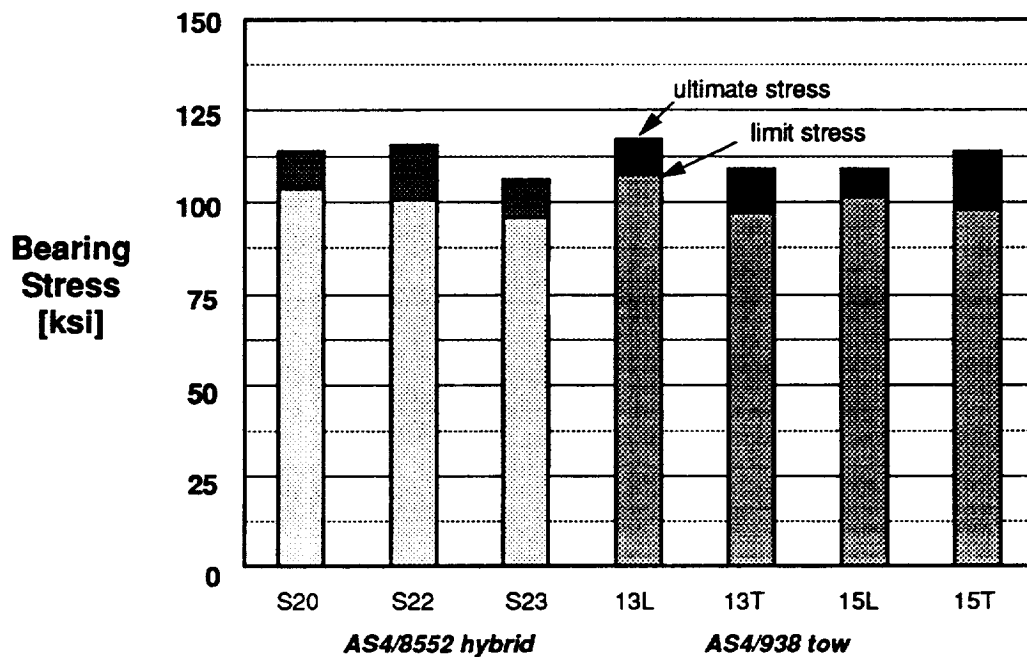
Figure D-20: Comparison of bearing strengths for AS4/8552 hybrid (MDOC keel & side panels) and AS4/938 tow (ATCAS crown panel) laminates.

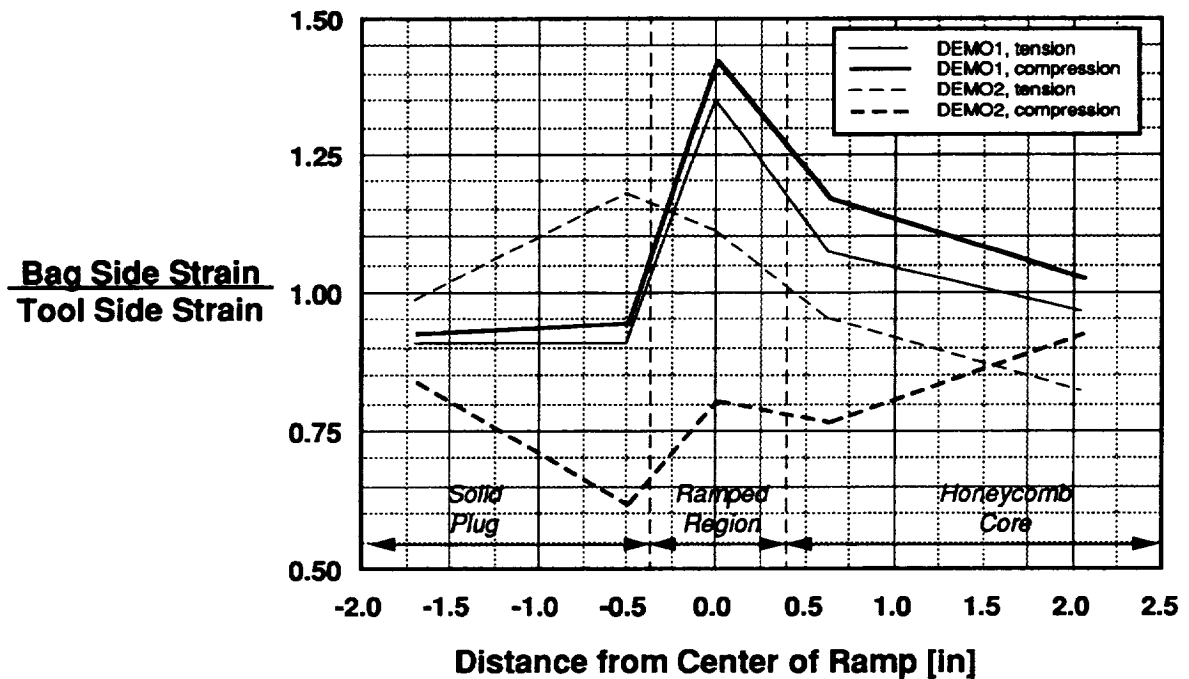
Figure E-7: Averaged ratio of bag side extensional strain to tool side extensional strain for tapered core specimens at initial failure.

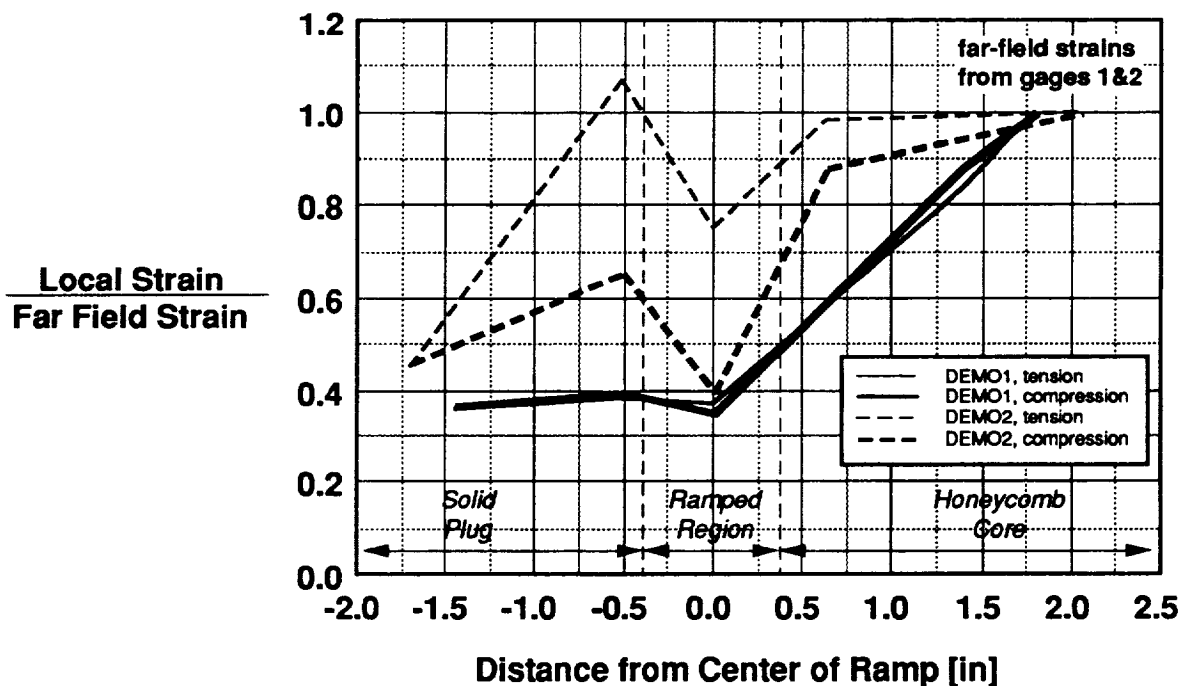
Figure E-8: Averaged ratio of local extensional strain to far field extensional strain (facesheets over honeycomb core) at initial failure.

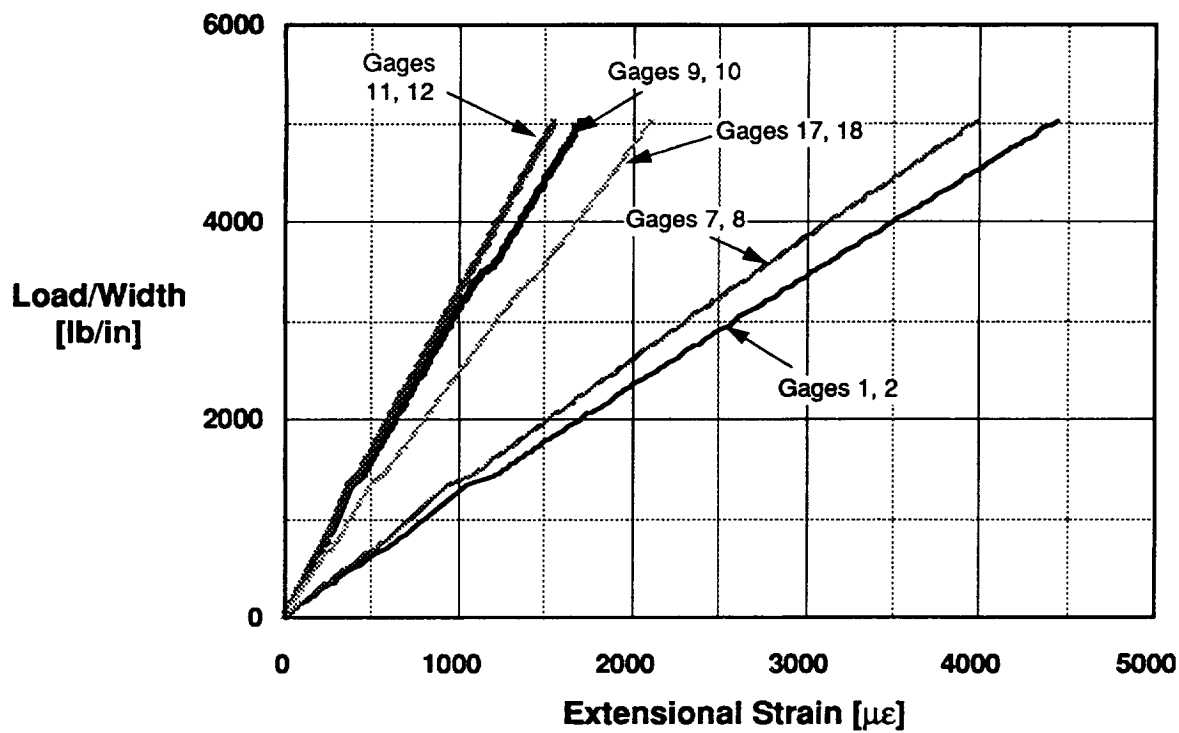
Figure E-9: Load-extensional strain behavior for specimen DEMO1-42 (solid plug in ramp, compression).

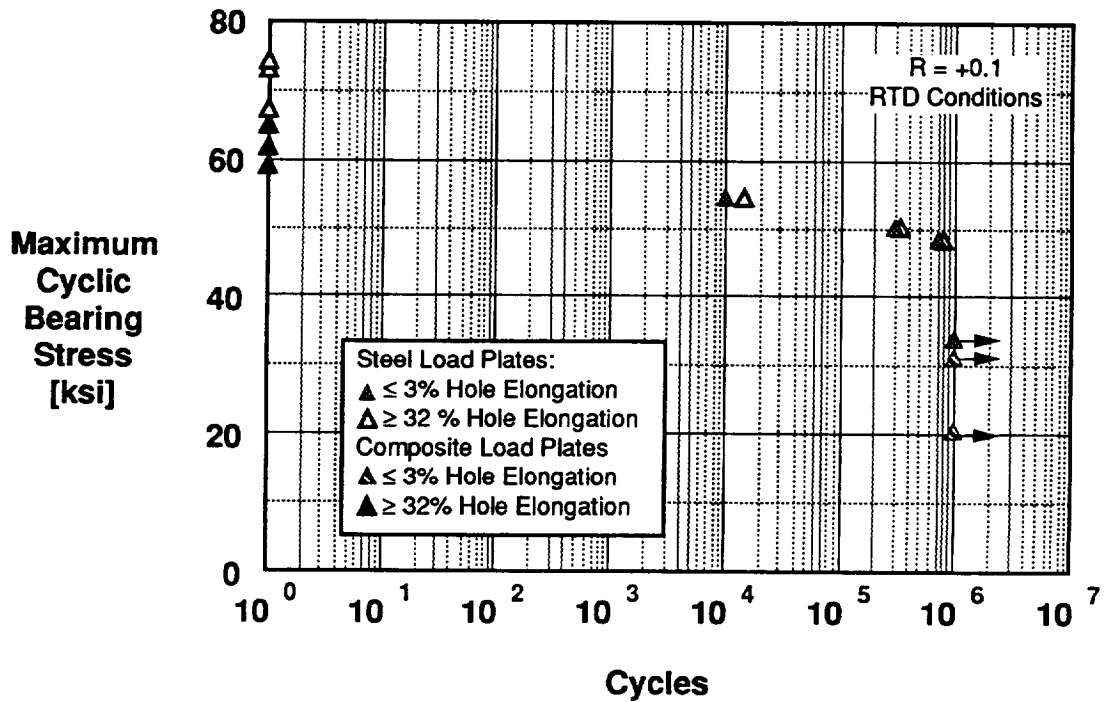
Figure E-17: S-N data for edgeband bearing failure (bearing stresses calculated for combined facesheet and closeout thickness).

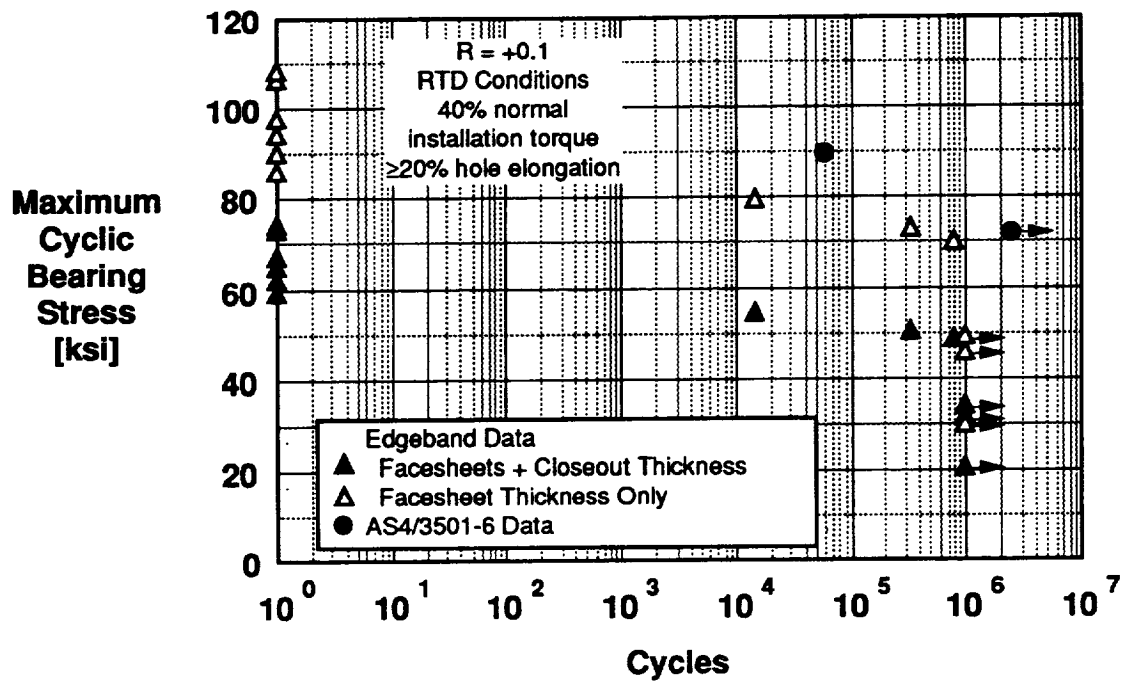
Figure E-18: Comparison of S-N data for edgebands with braided closeouts and AS4/3501-6 plain weave fabric laminates.

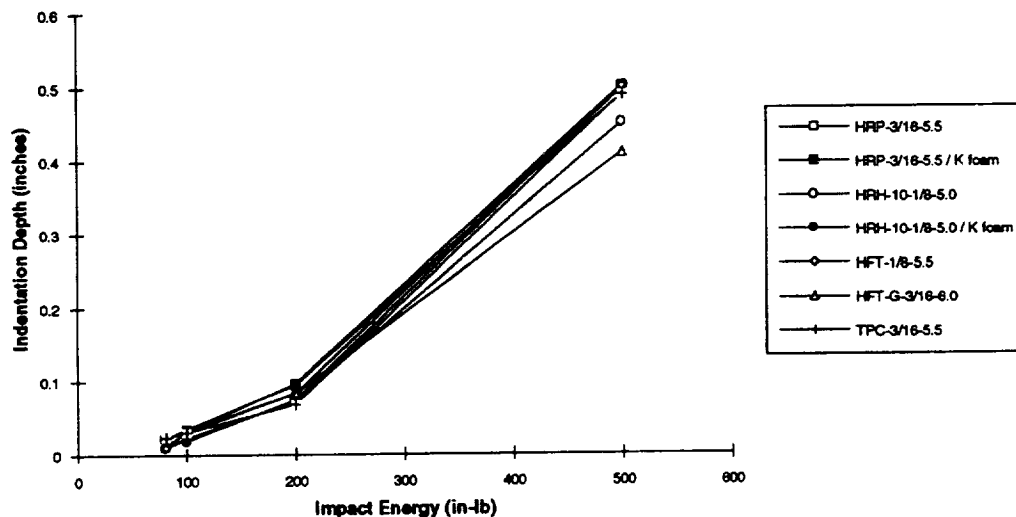
Figure F-1. Indentation Depth Following Impact of Representative Minimum Gage Sandwich Structure with Candidate Honeycomb Core Materials.

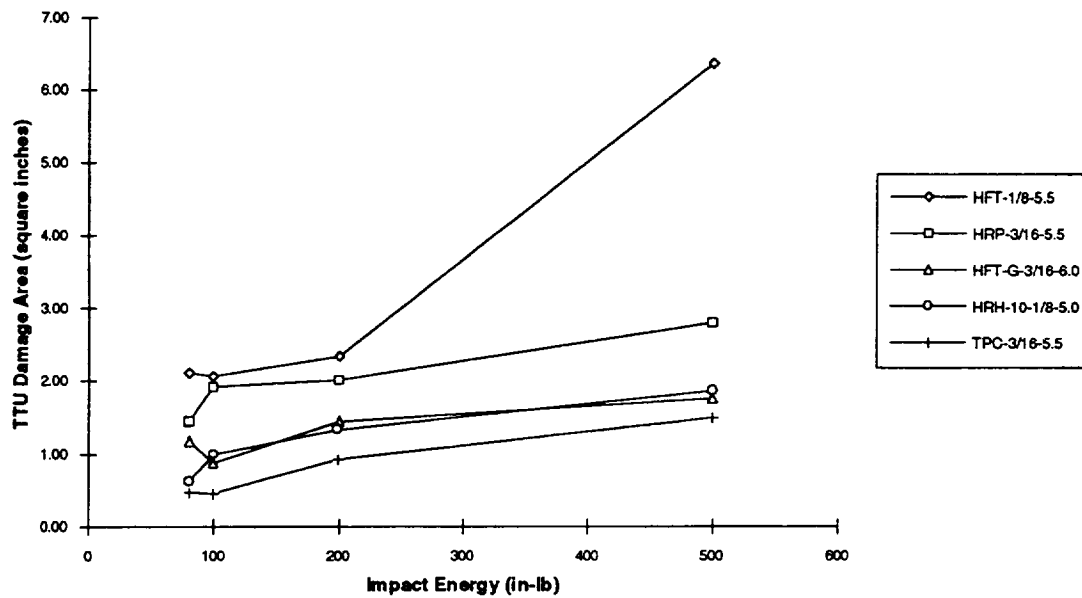
Figure F-2. Impact Damage Resistance of Representative Minimum Gage Sandwich Structure with Candidate Honeycomb Core Materials.

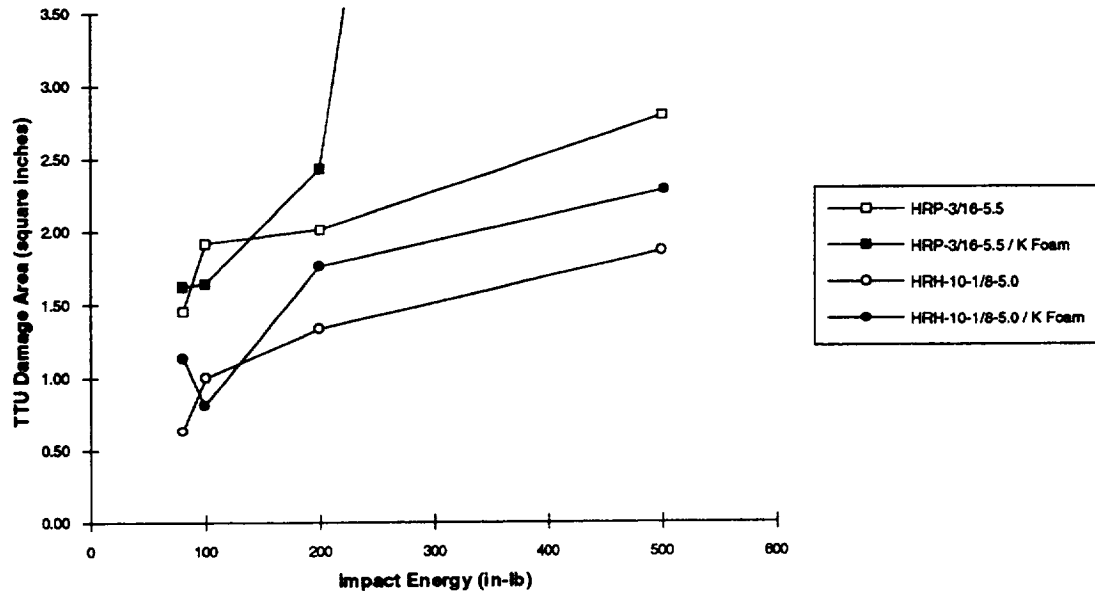
Figure F-3. Impact Damage Resistance of Representative Minimum Gage Sandwich Structure with Foam-Filled Honeycomb Core Materials.

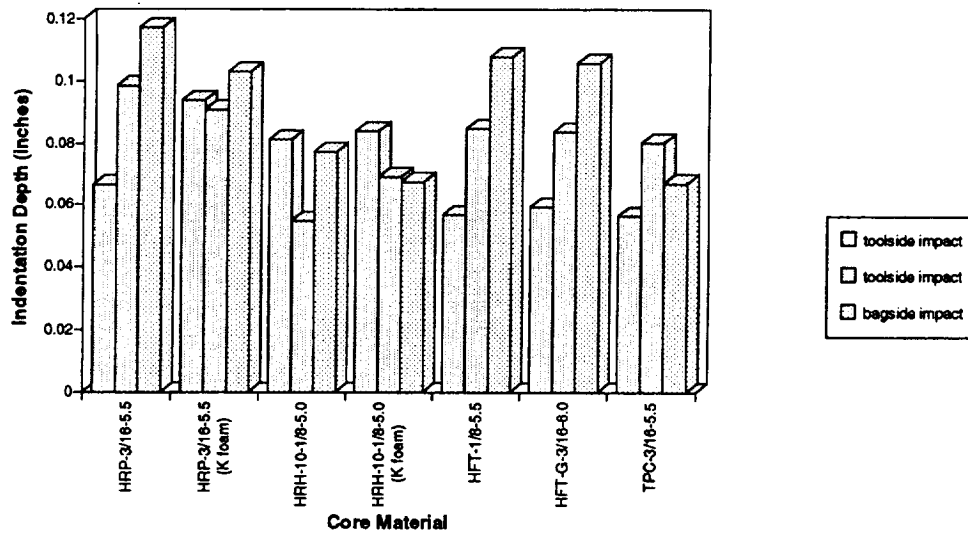
Figure F-4. Bagside and Toolside Impact Damage Resistance of Representative Minimum Gage Sandwich Structure (Indentation Depth).

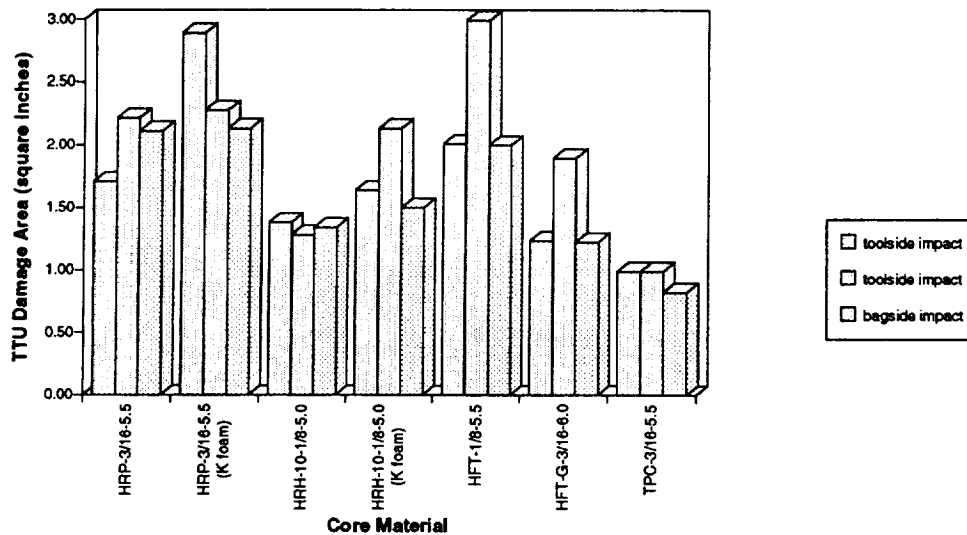
Figure F-5. Bagside and Toolside Impact Damage Resistance of Representative Minimum Gage Sandwich Structure (Damage Area).

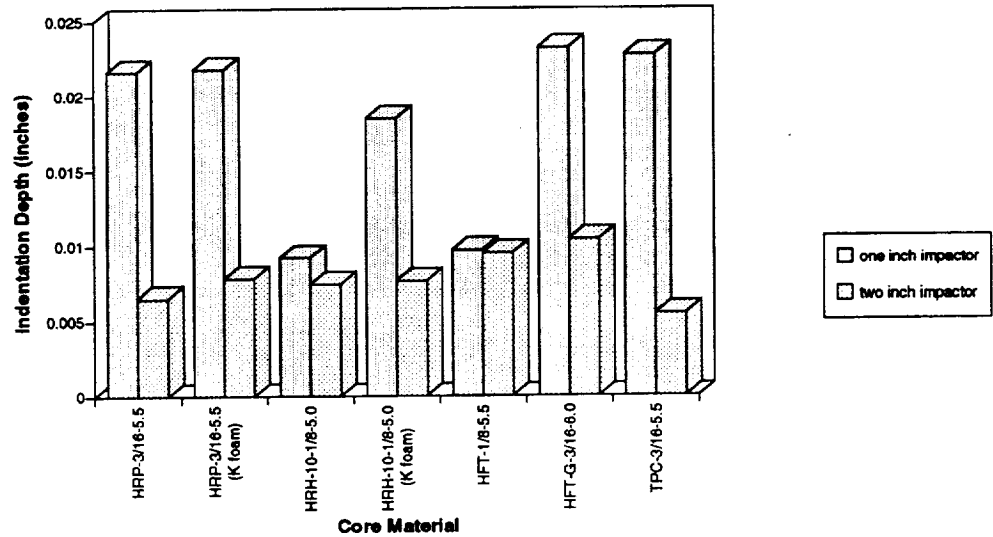
Figure F-6. Effect of Impactor Diameter on Indentation Depth.

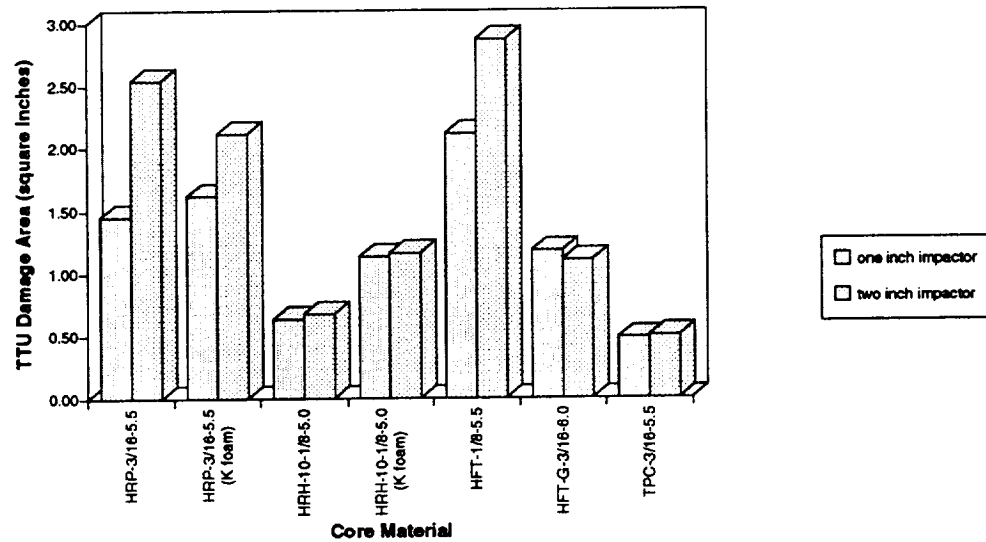
Figure F-7. Effect of Impactor Diameter on Damage Area.

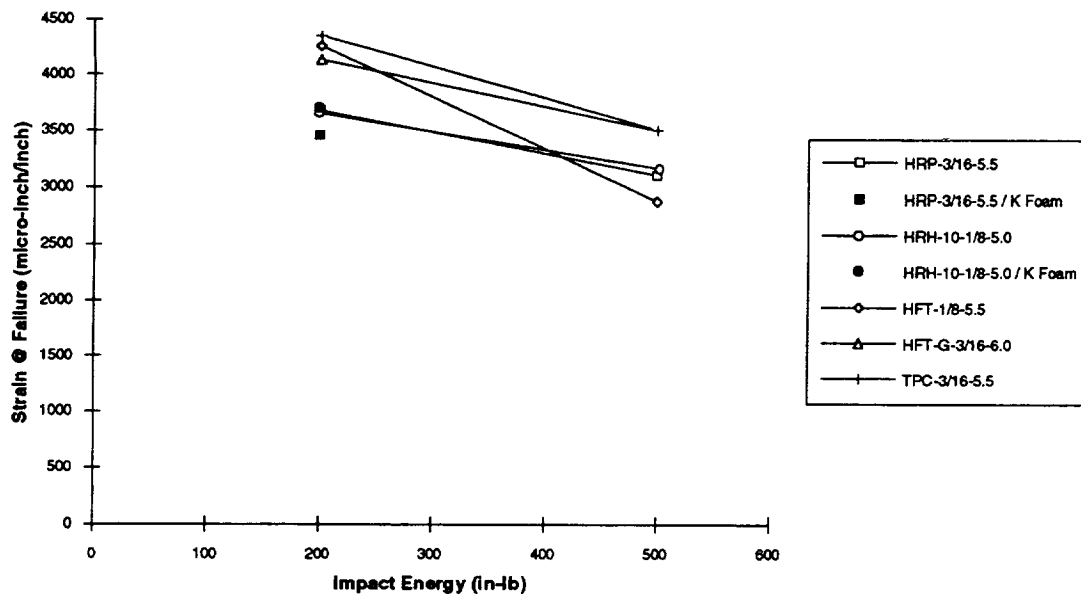
Figure F-8. CAI Strain at Failure of Representative Minimum Gage Sandwich Panels with Candidate Honeycomb Core Materials.

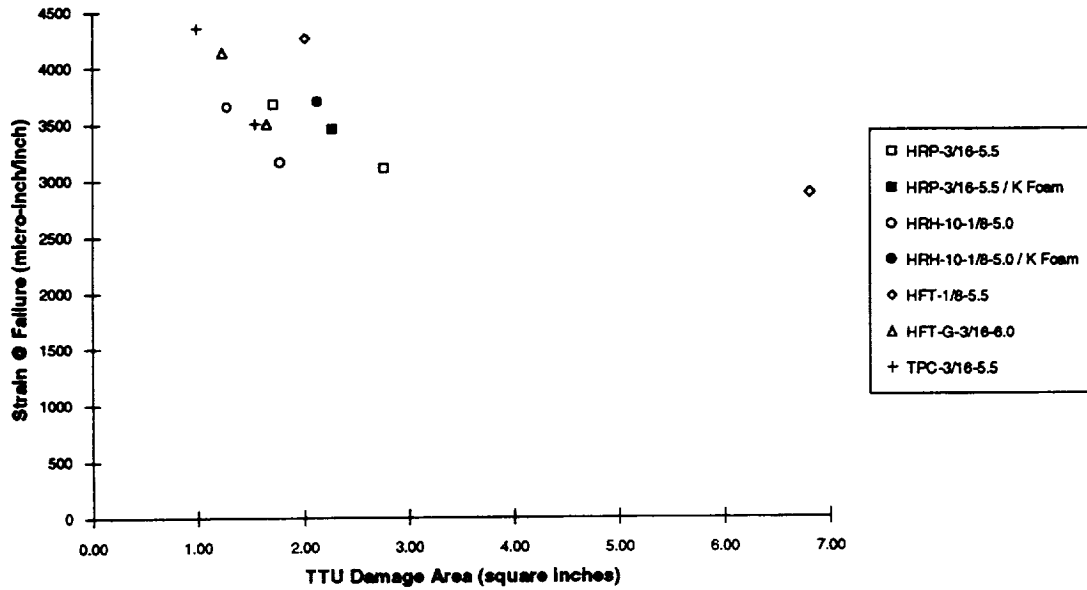
Figure F-9. Correlation of CAI Strain at Failure with Impact Damage Area.

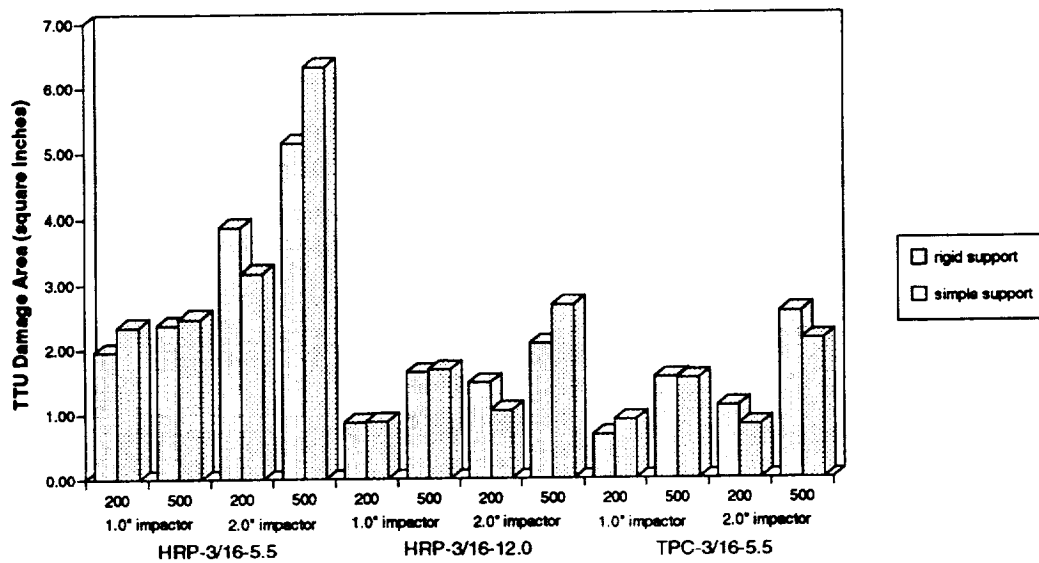
Figure G-2: Effect of Impact Support Type on Damage Area in Composite Sandwich Structures.

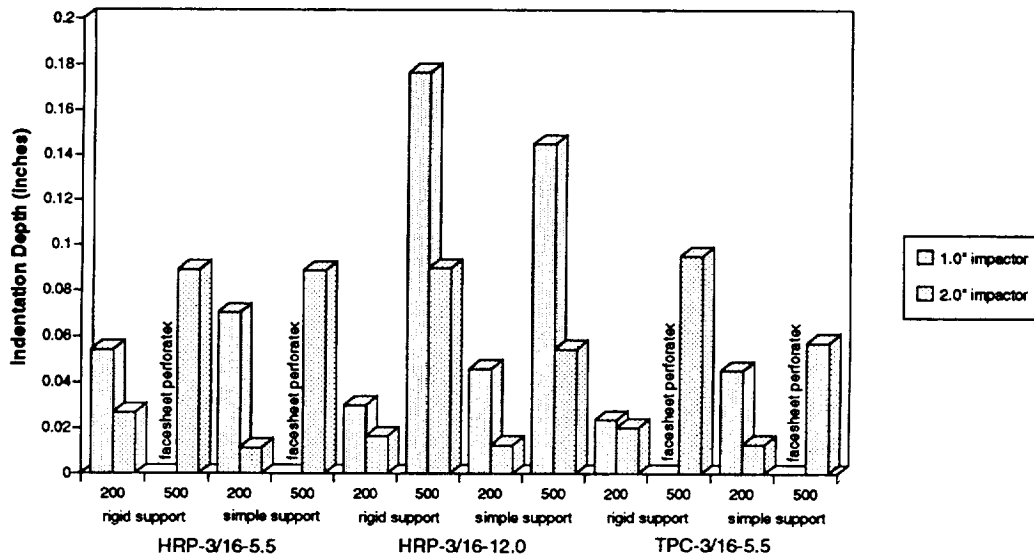
Figure G-3: Effect of Impactor Diameter on Indentation Depth in Composite Sandwich Structures.

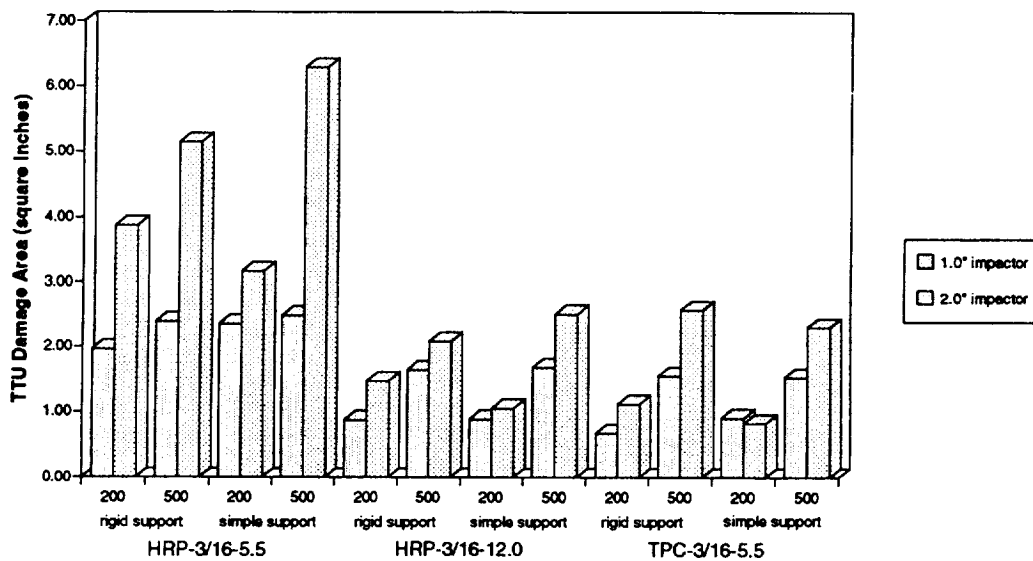
Figure G-4: Effect of Impactor Diameter on Damage Area in Composite Sandwich Structures.

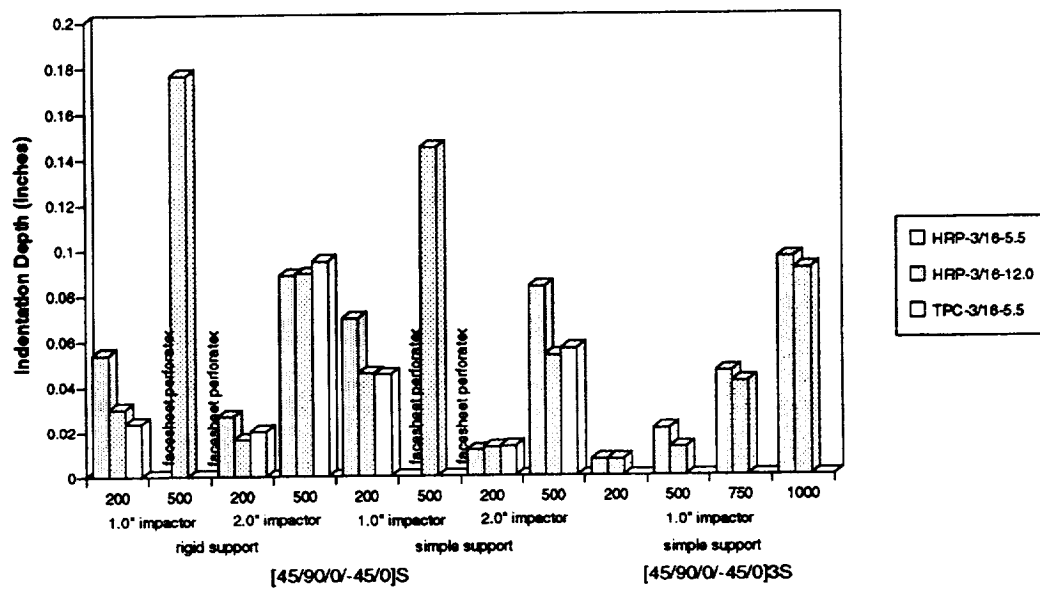
Figure G-5: Effect of Core Material Type and Density on Indentation Depth in Composite Sandwich Structures.

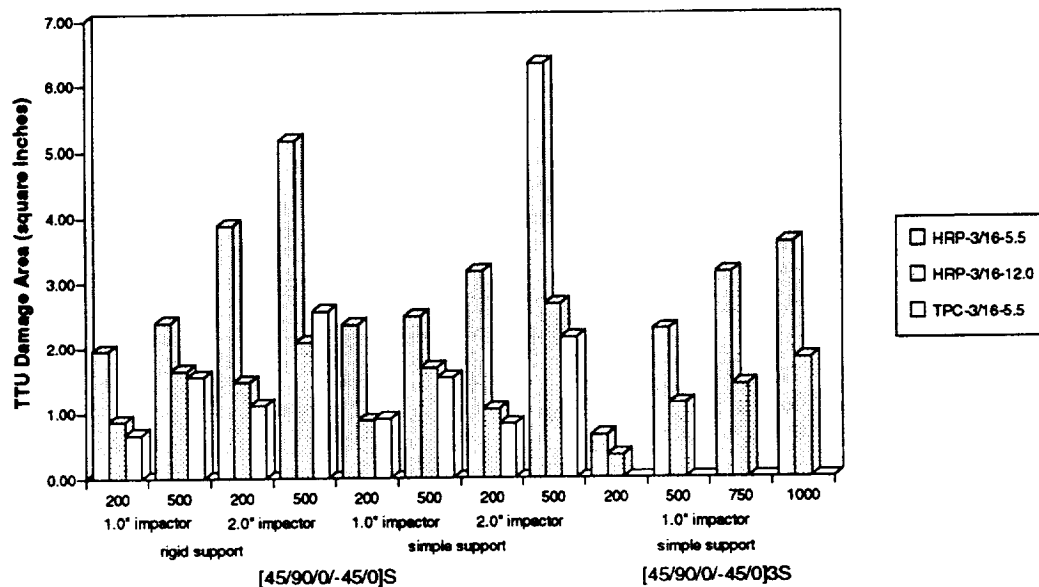
Figure G-6: Effect of Impactor Diameter on Damage Area in Composite Sandwich Structures.
